St. Regis Paper Mill

Architectural and Environmental Survey

Final Report

Prepared for Fort Drum
Directorate of Public Works
Cultural Resources Management
Fort Drum, New York 13602

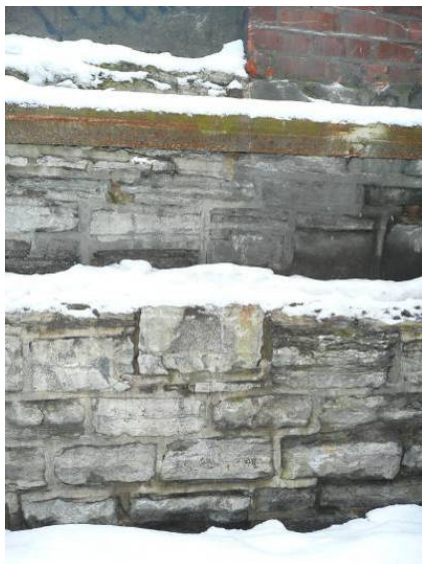
Figure 143. Exterior of foundation condition on southwest elevation of paper mill.

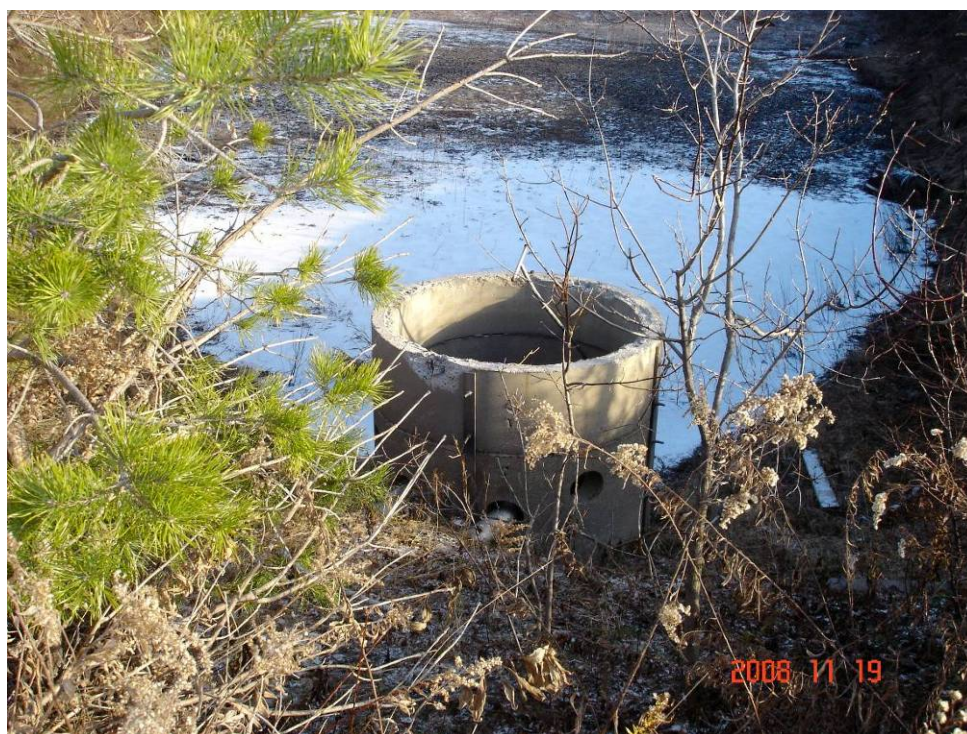
Figure 270. Ash pond overflow.

The ash pond that received wastes from the boiler plant is not lined, and is likely to be a source of contamination to underlying soil and groundwater. The New York State Department of Environmental Conservation required that the Site develop a plan for a hydrogeological investigation, and submit it to the State for approval. CERL was told that this plan was completed. However, CERL found no evidence of groundwater monitoring wells during the site visit, so it is unlikely that the plan has been implemented.

Sediment in the ash pond and the coal storage site may contain heavy metals, and perhaps other contaminants. Surface samples should be taken to determine if the materials are hazardous. Unless there is a compelling training rationale, these areas should be off limits to soldiers until the areas are proven to be nonhazardous, or have been remediated. The concern is less about soldier health than a desire to not complicate clean-up responsibility.
